# Scientific Investigation/ Survey at Settlement Plot No. 9130, District Varanasi

(Report submitted to the Hon'ble District Court, Varanasi)

Archaeological Survey of India  
2023

Volume 1

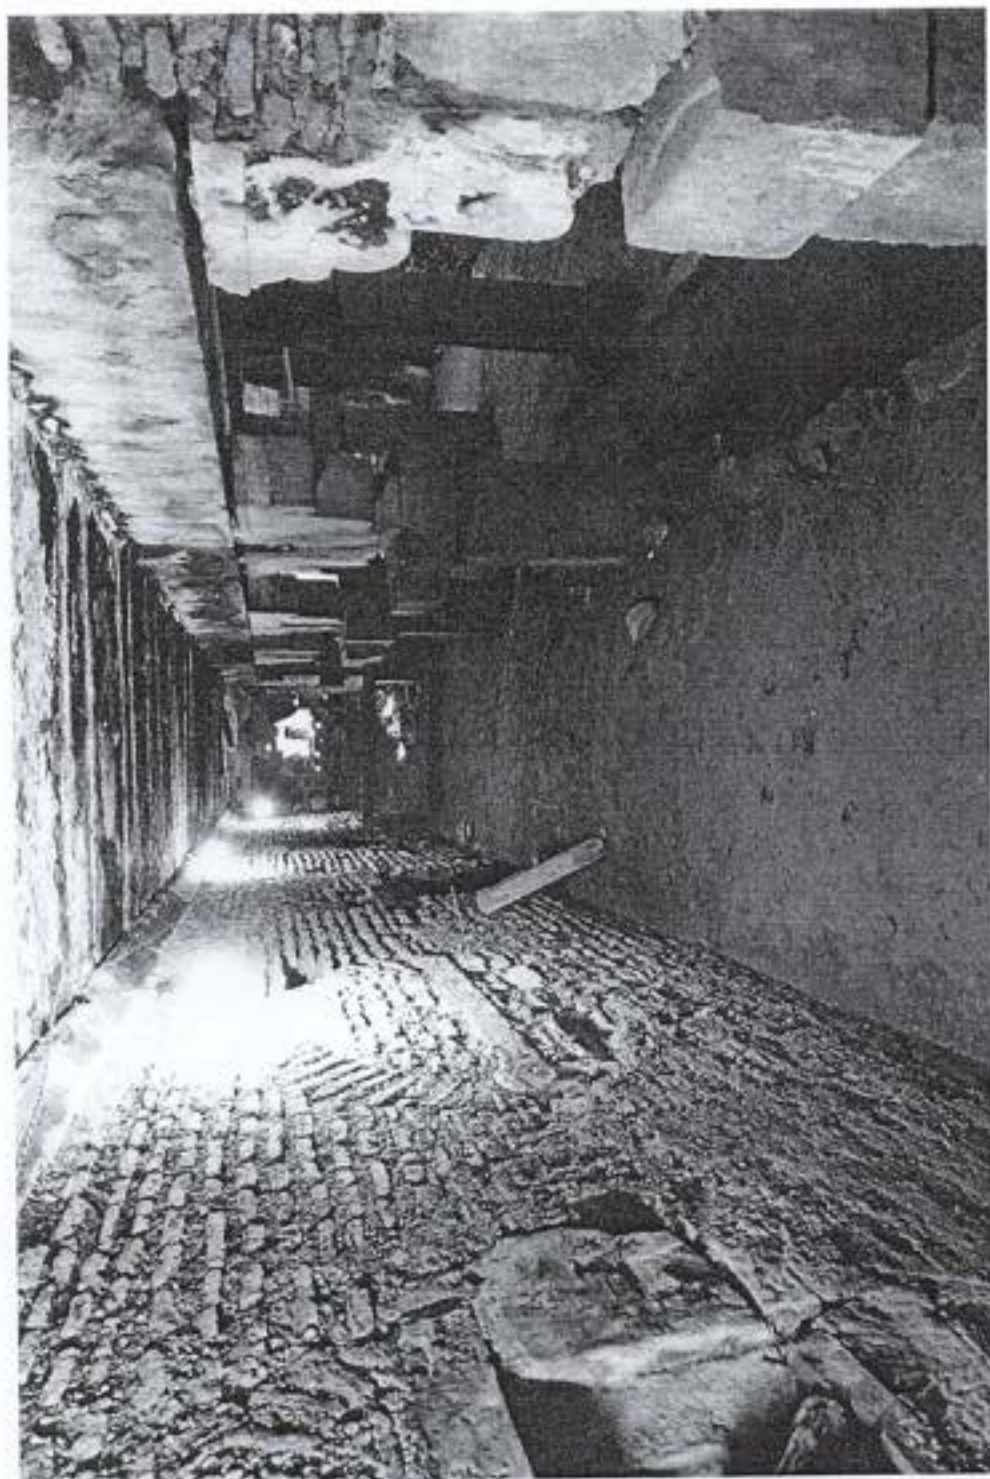
Cellar S1: Blocked entrances in west wall

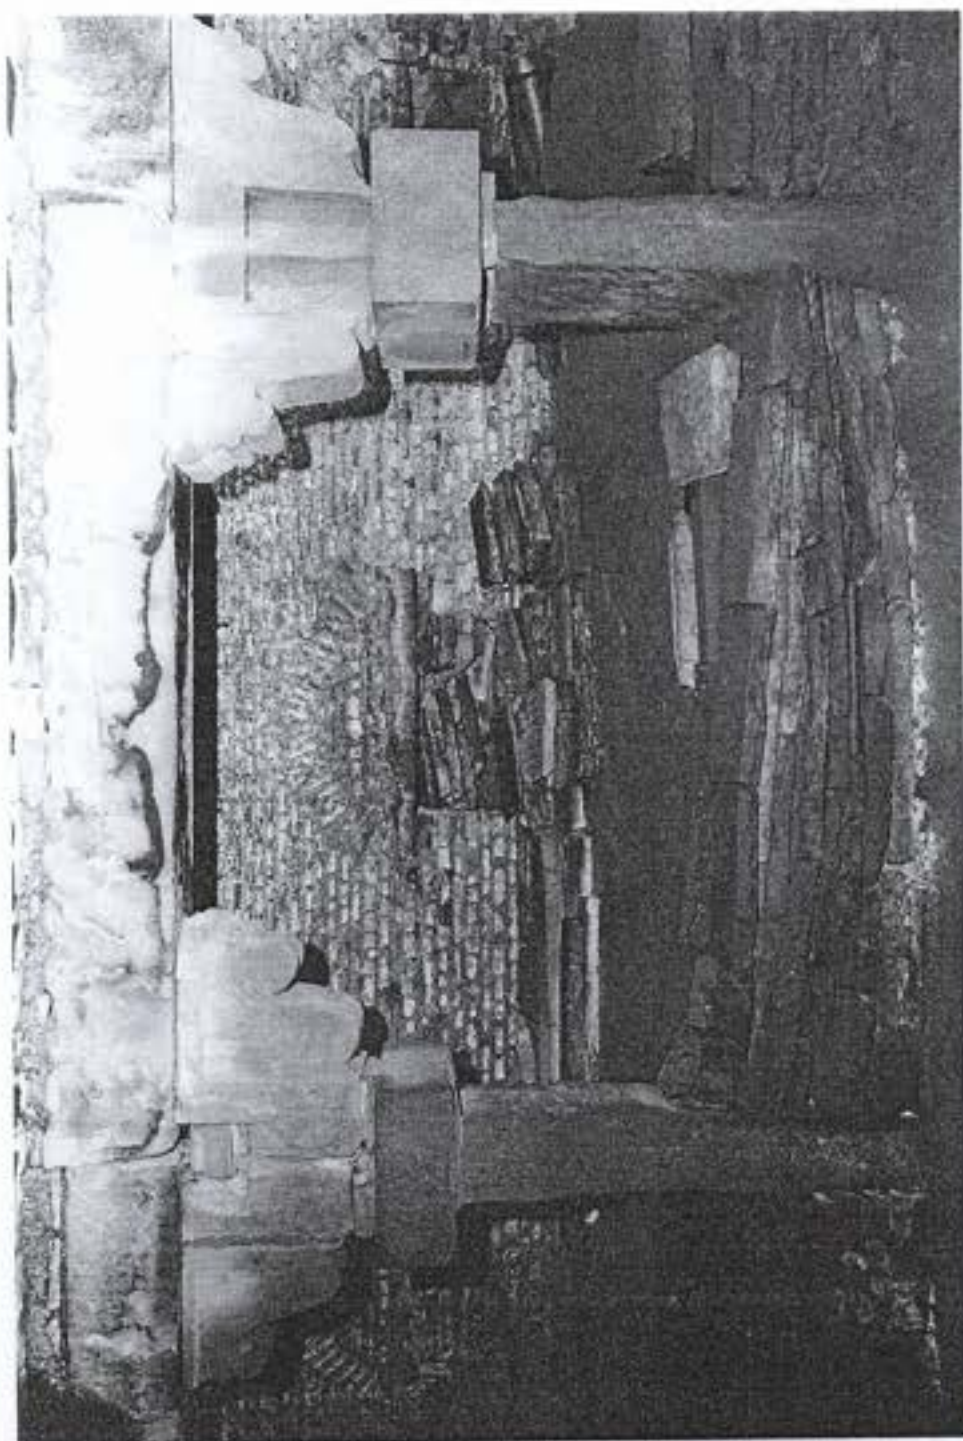
Cellar S1: Blocked entrances, 2, 3 and 4

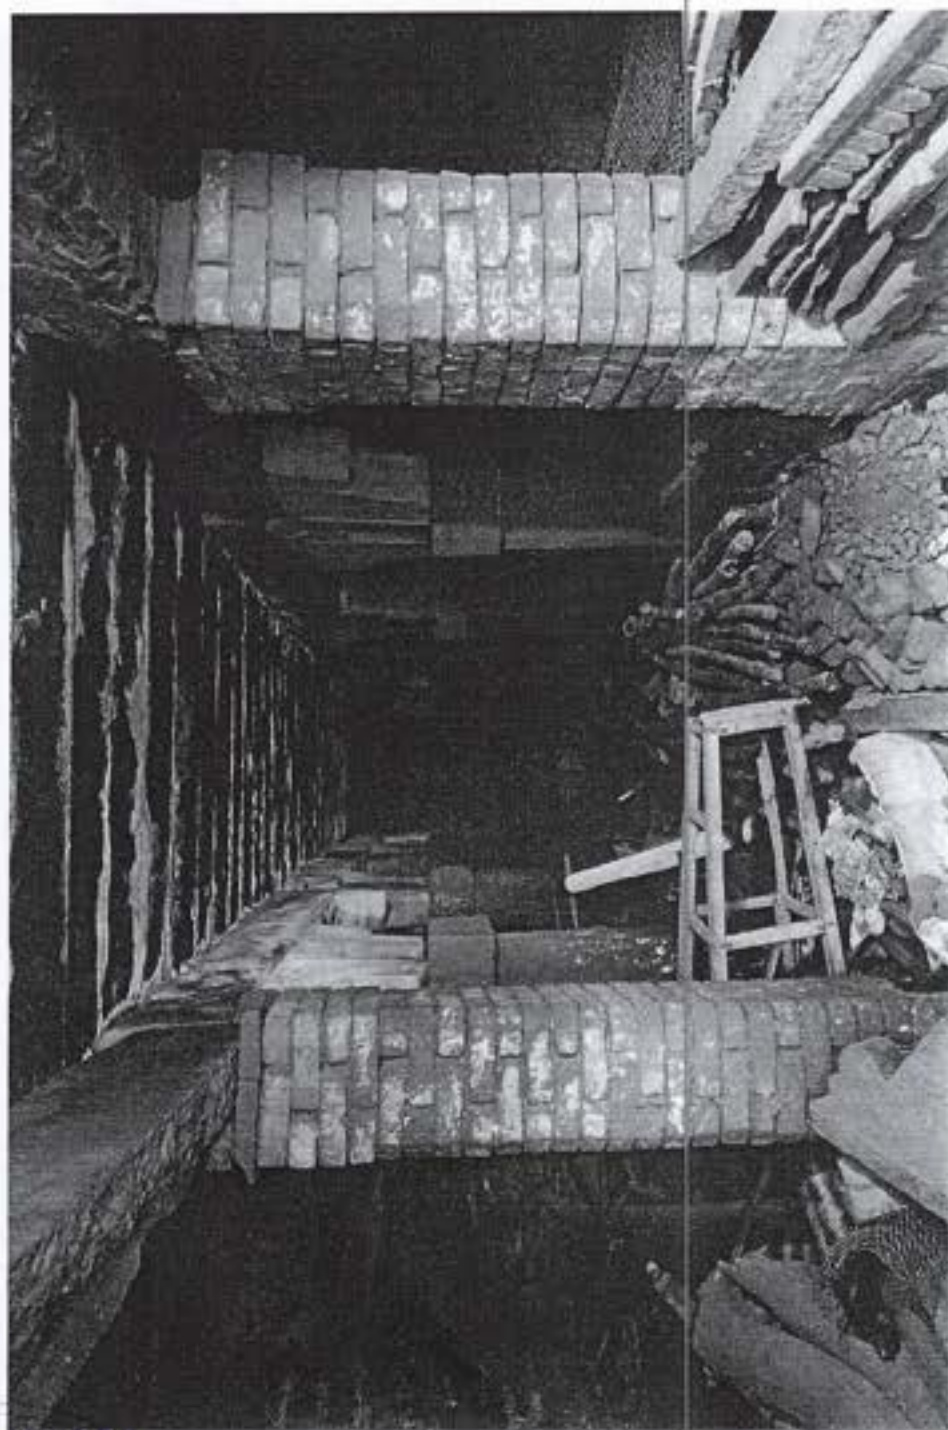
Cellar S2: Dumped material, before cleaning

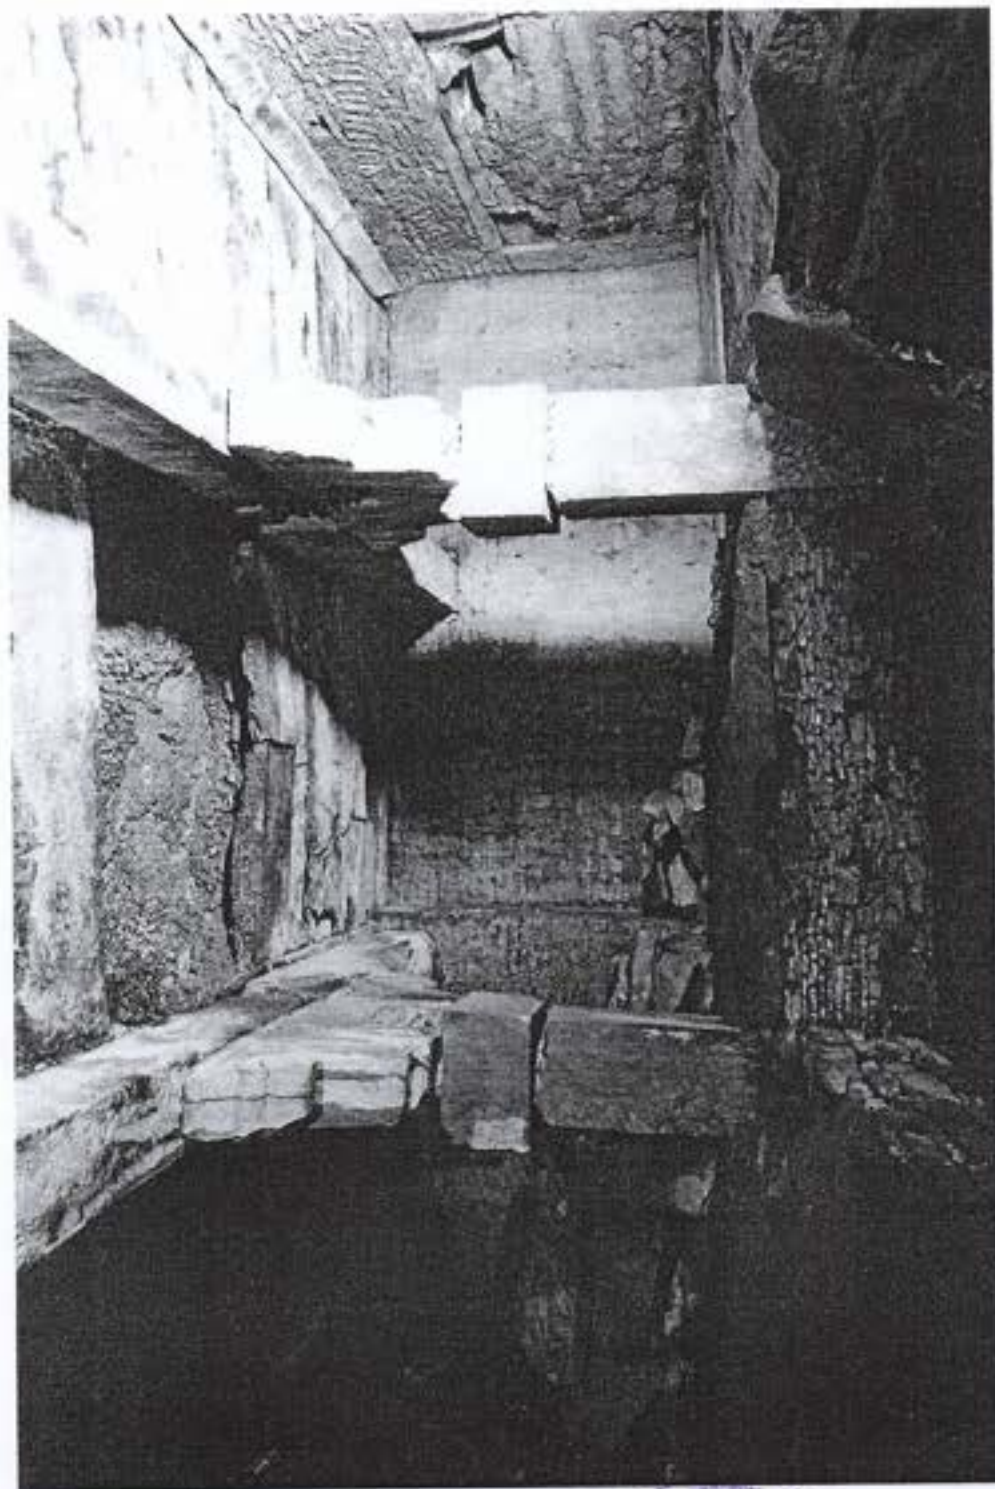
Cellar S2: Northern wall and damaged ceiling

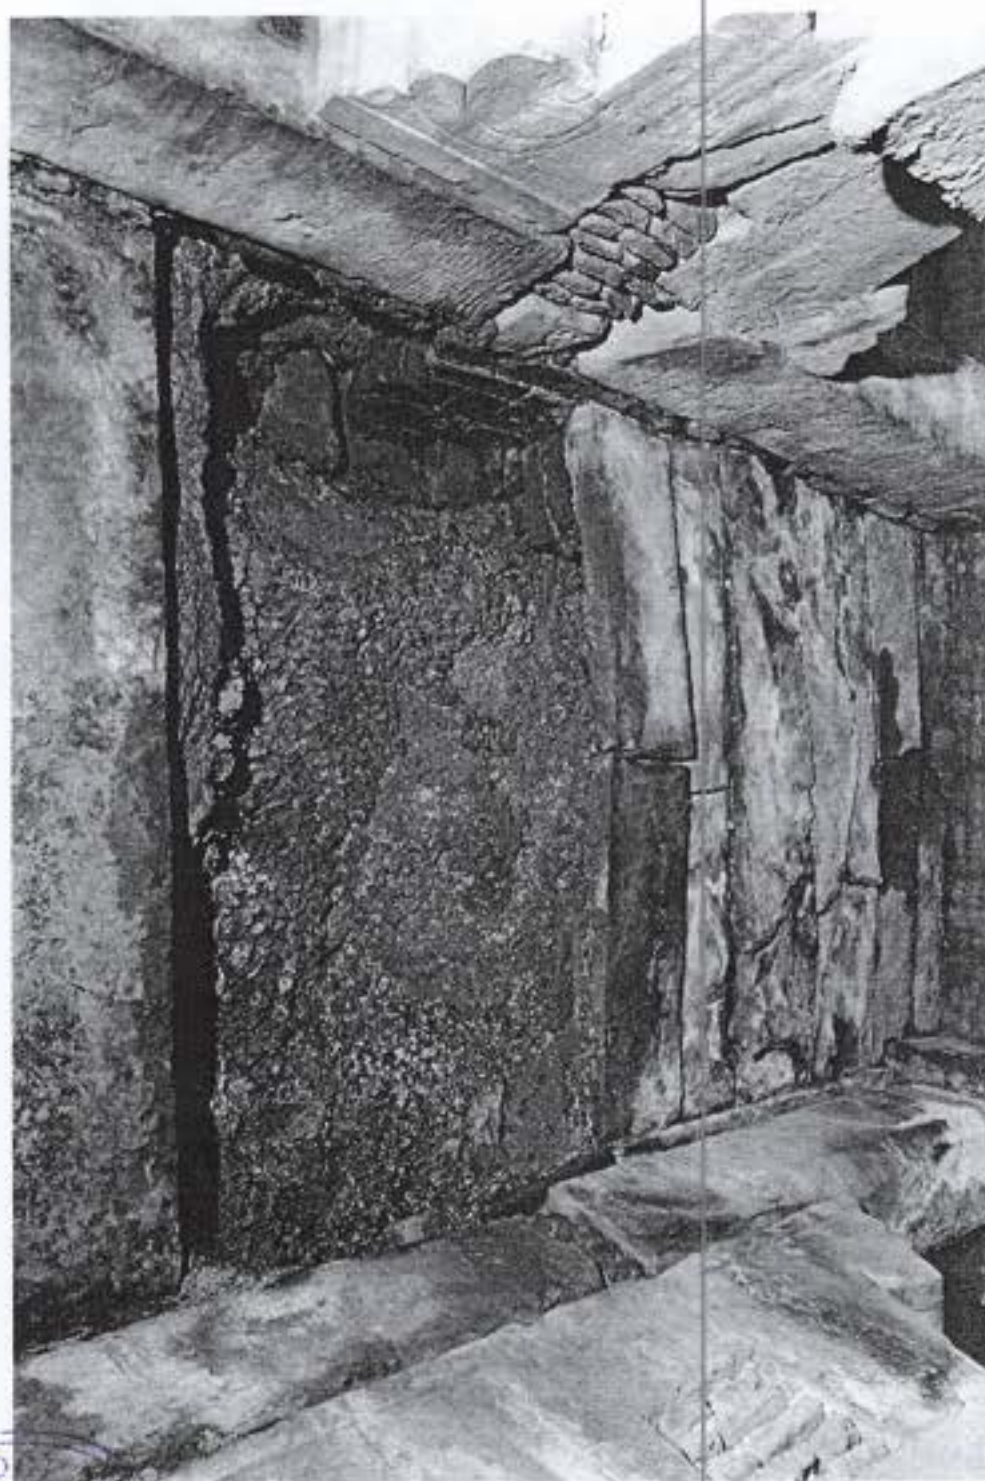
Cellar S2: Damaged ceiling

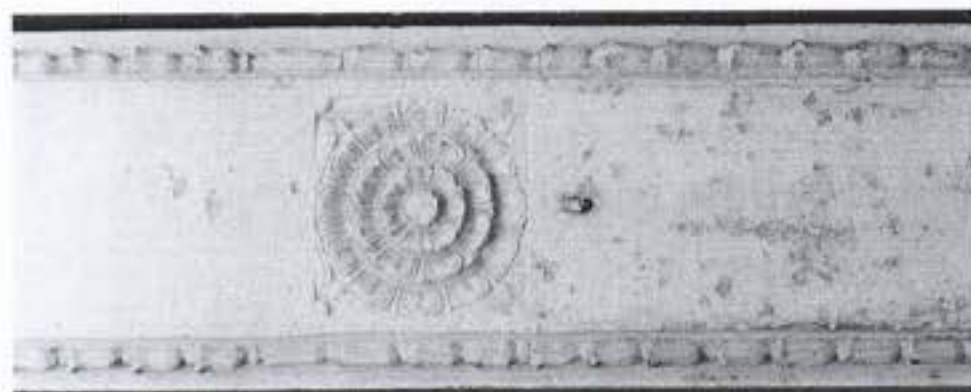
Pillar and Pilaster: Roughly carved flower buds

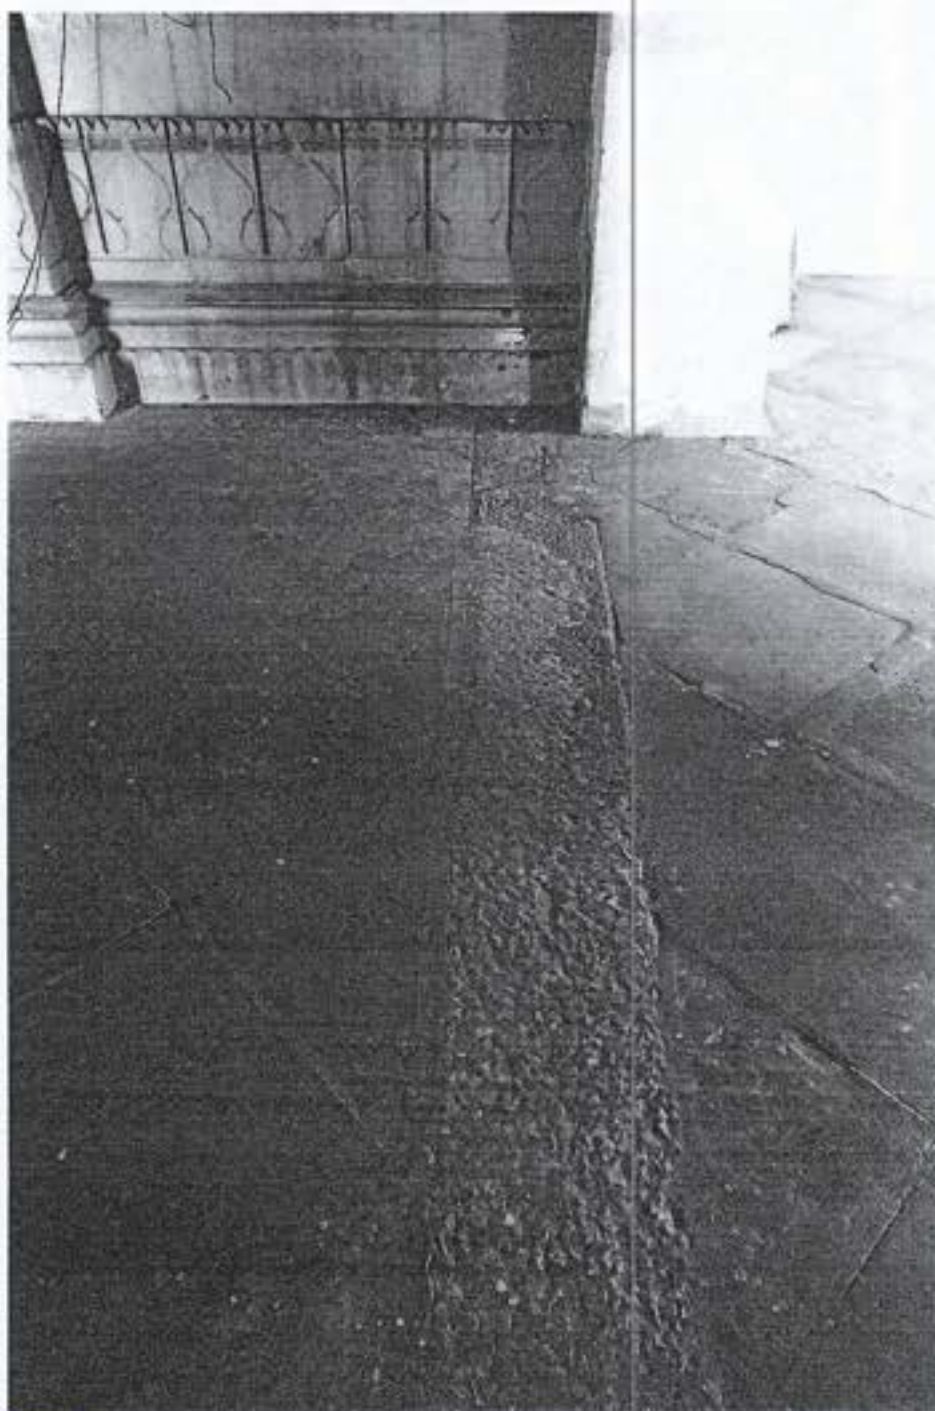
Central Hall: Heavy slab running beneath the arch at floor level

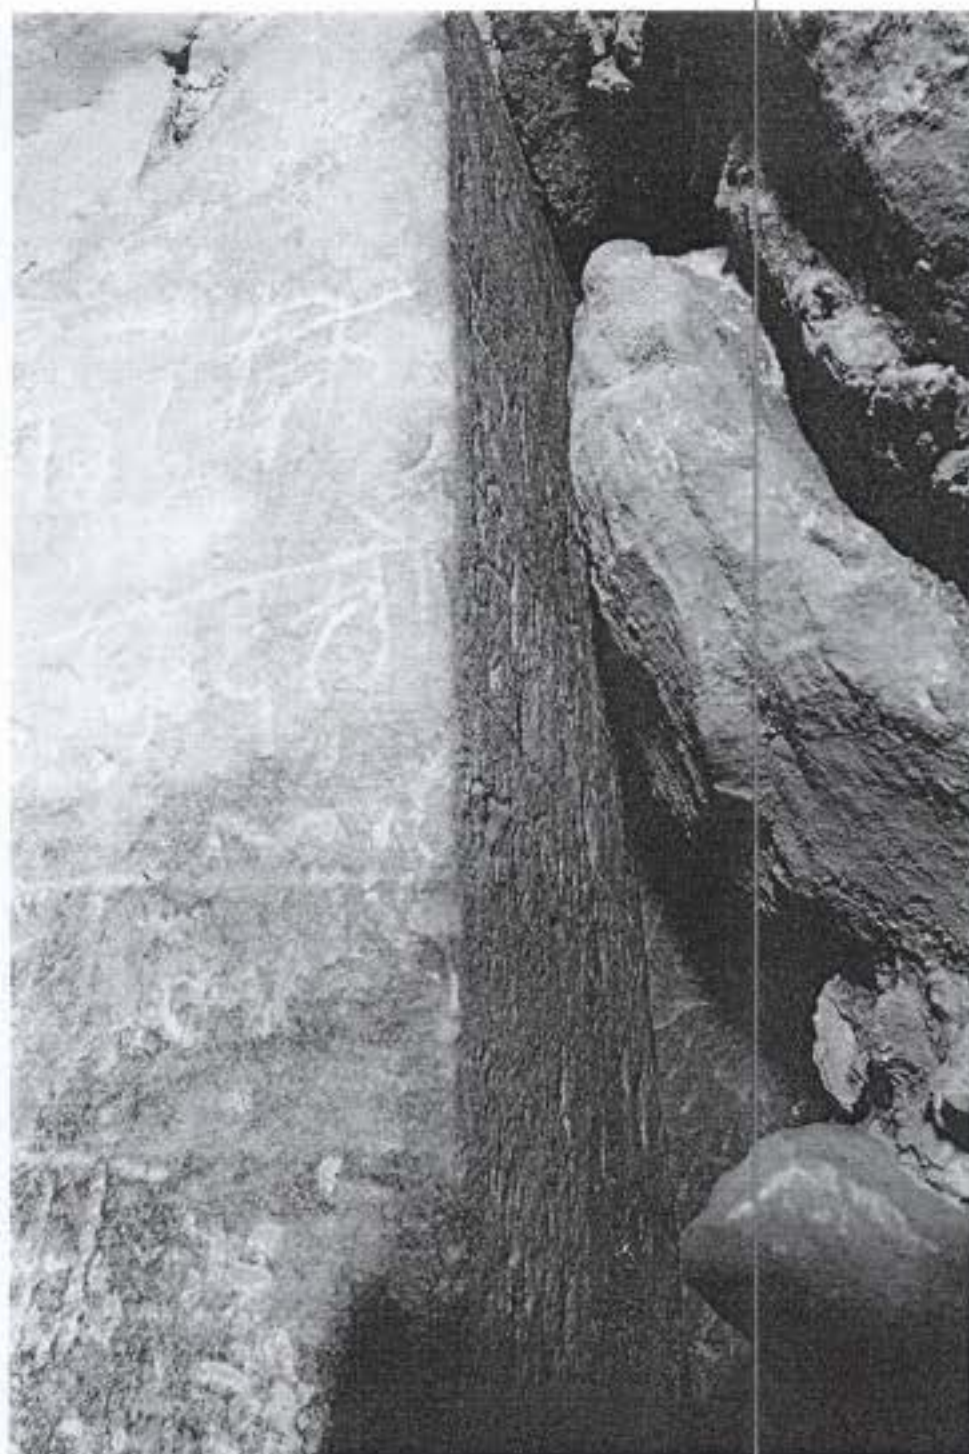
Southern Stairs: Inscription

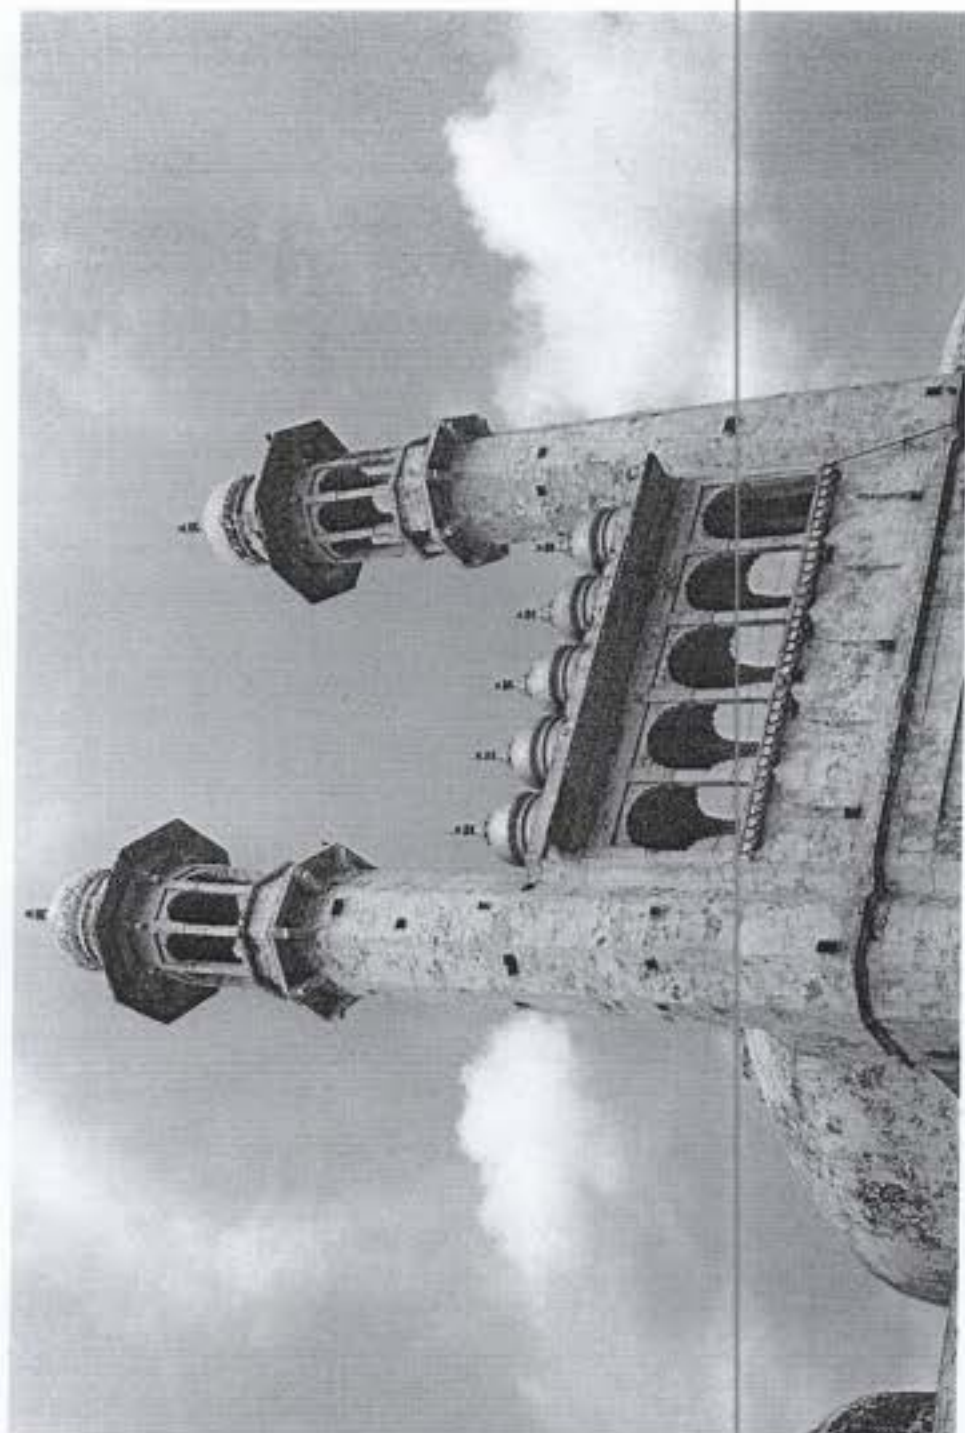
Minarets above main entrance

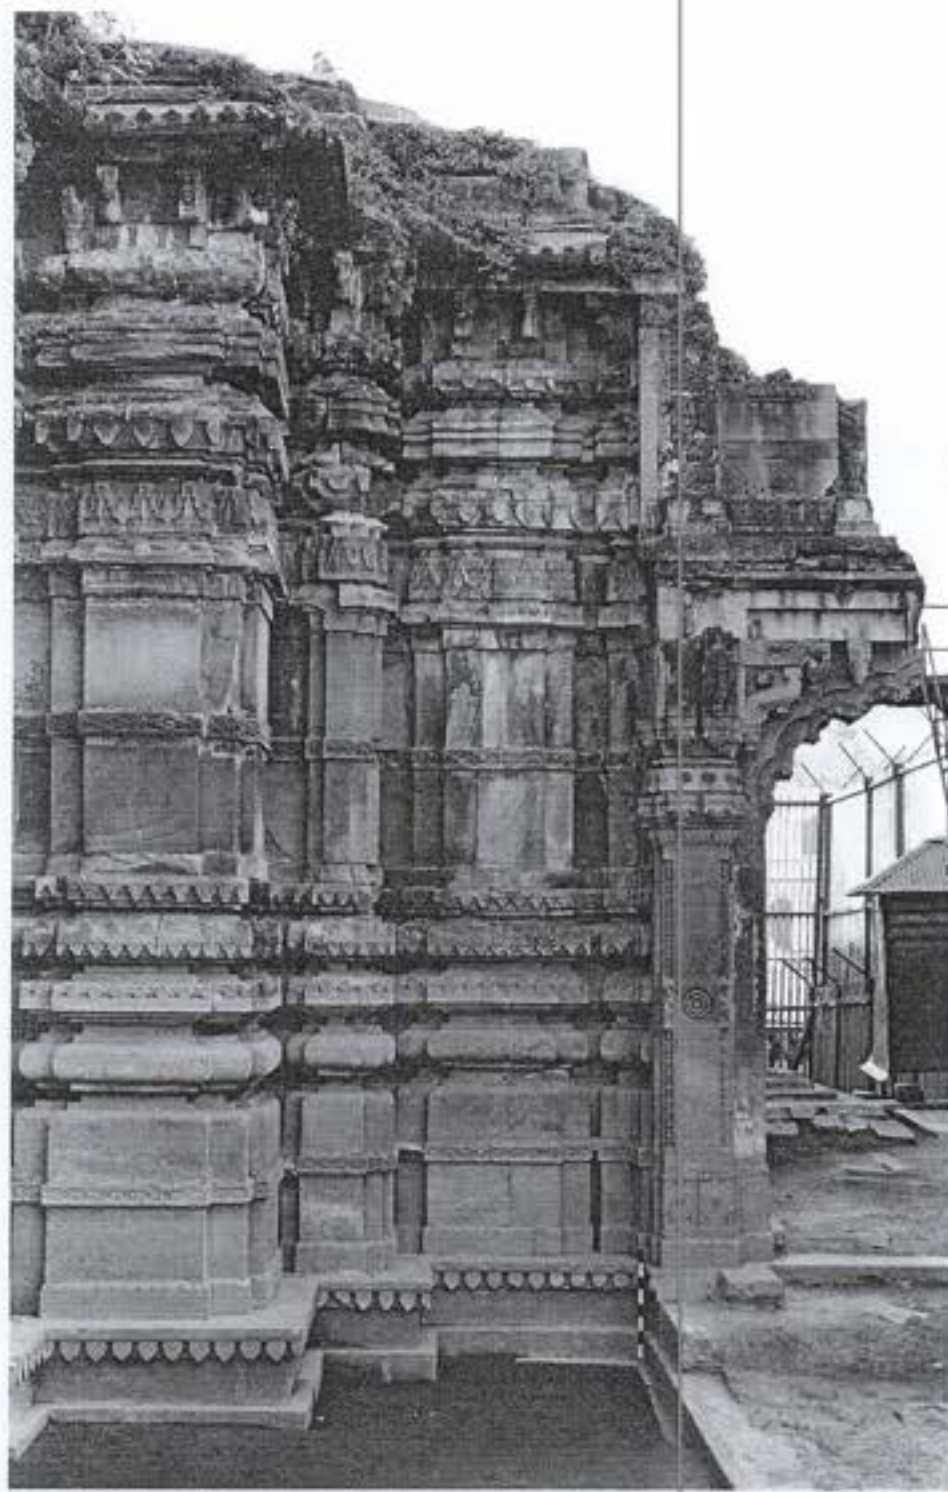
Western Chamber: Northern wall with arched gateway

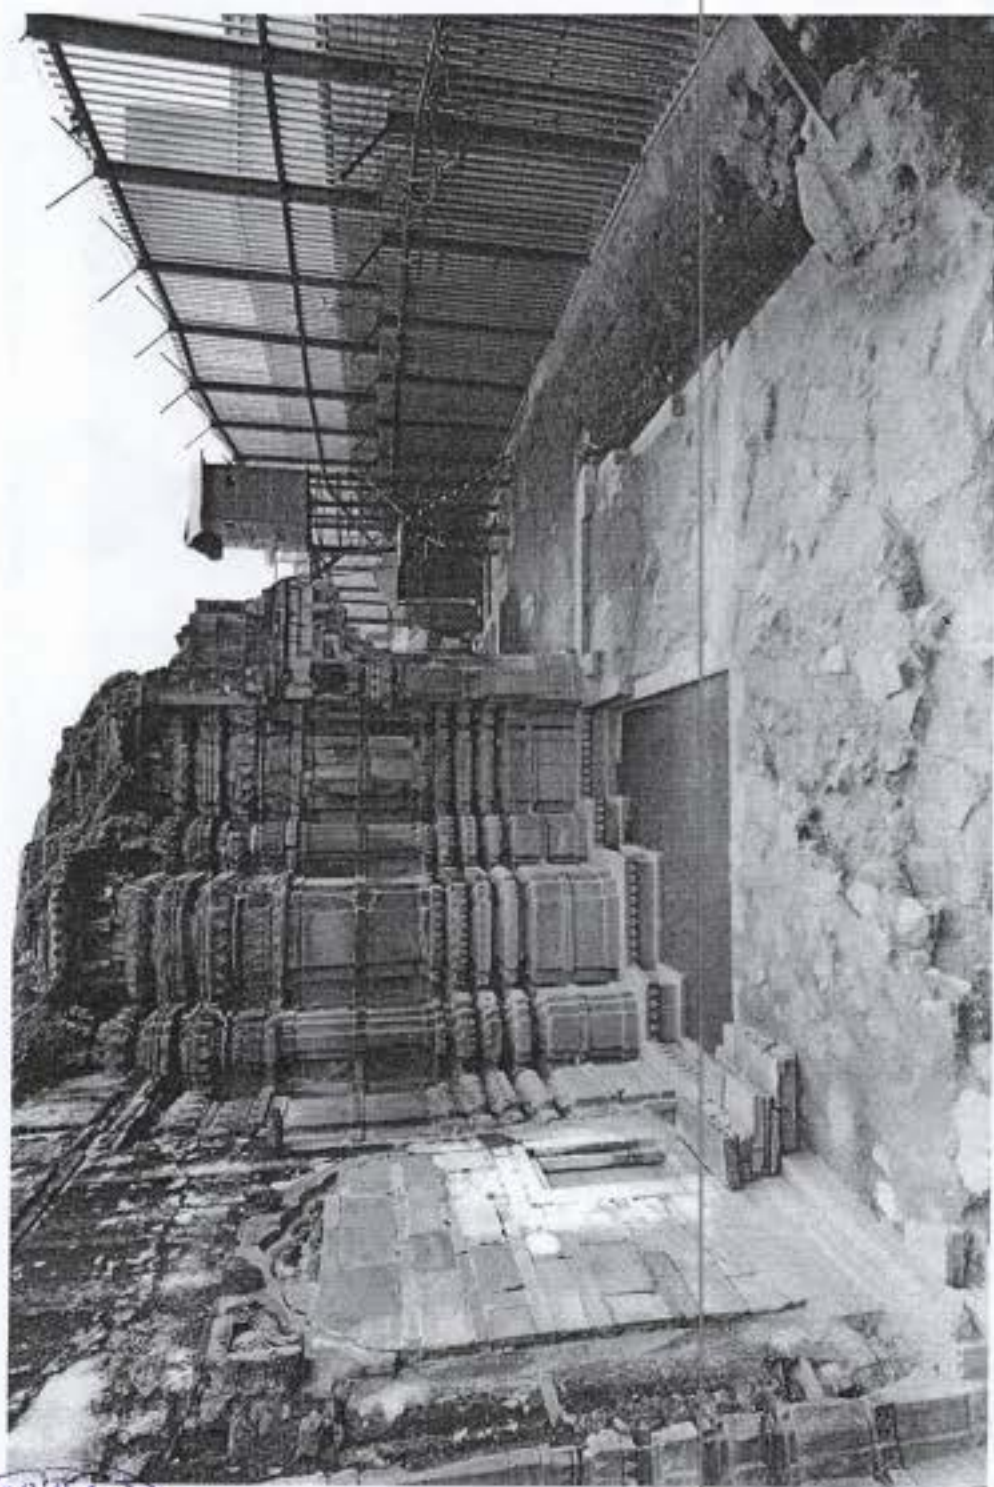
Northwest Side: Exposed structures

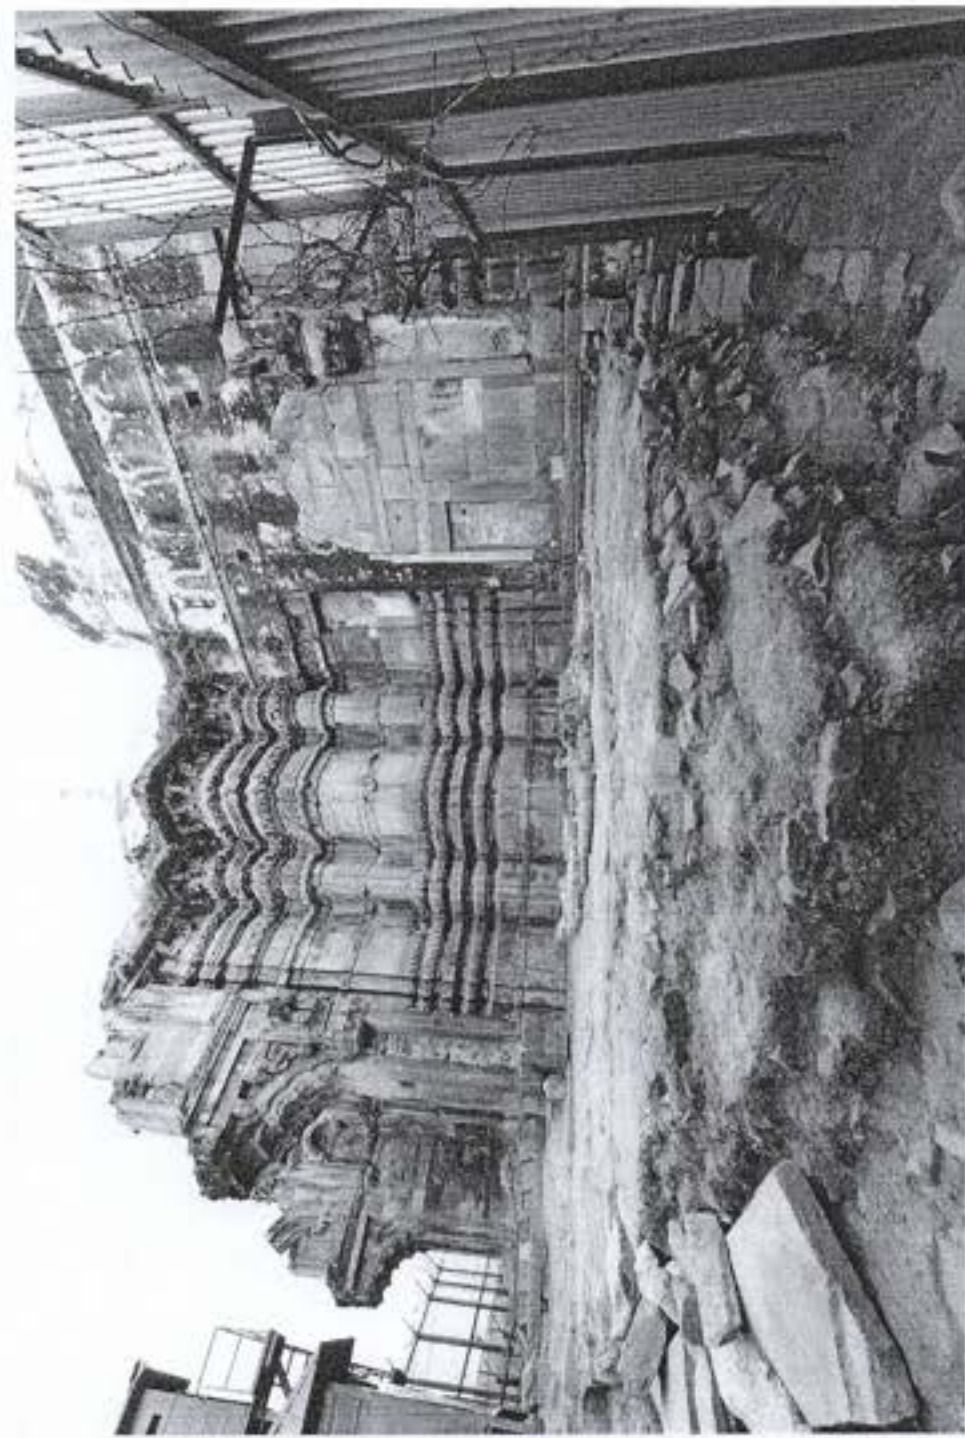
Southwest Side: General view

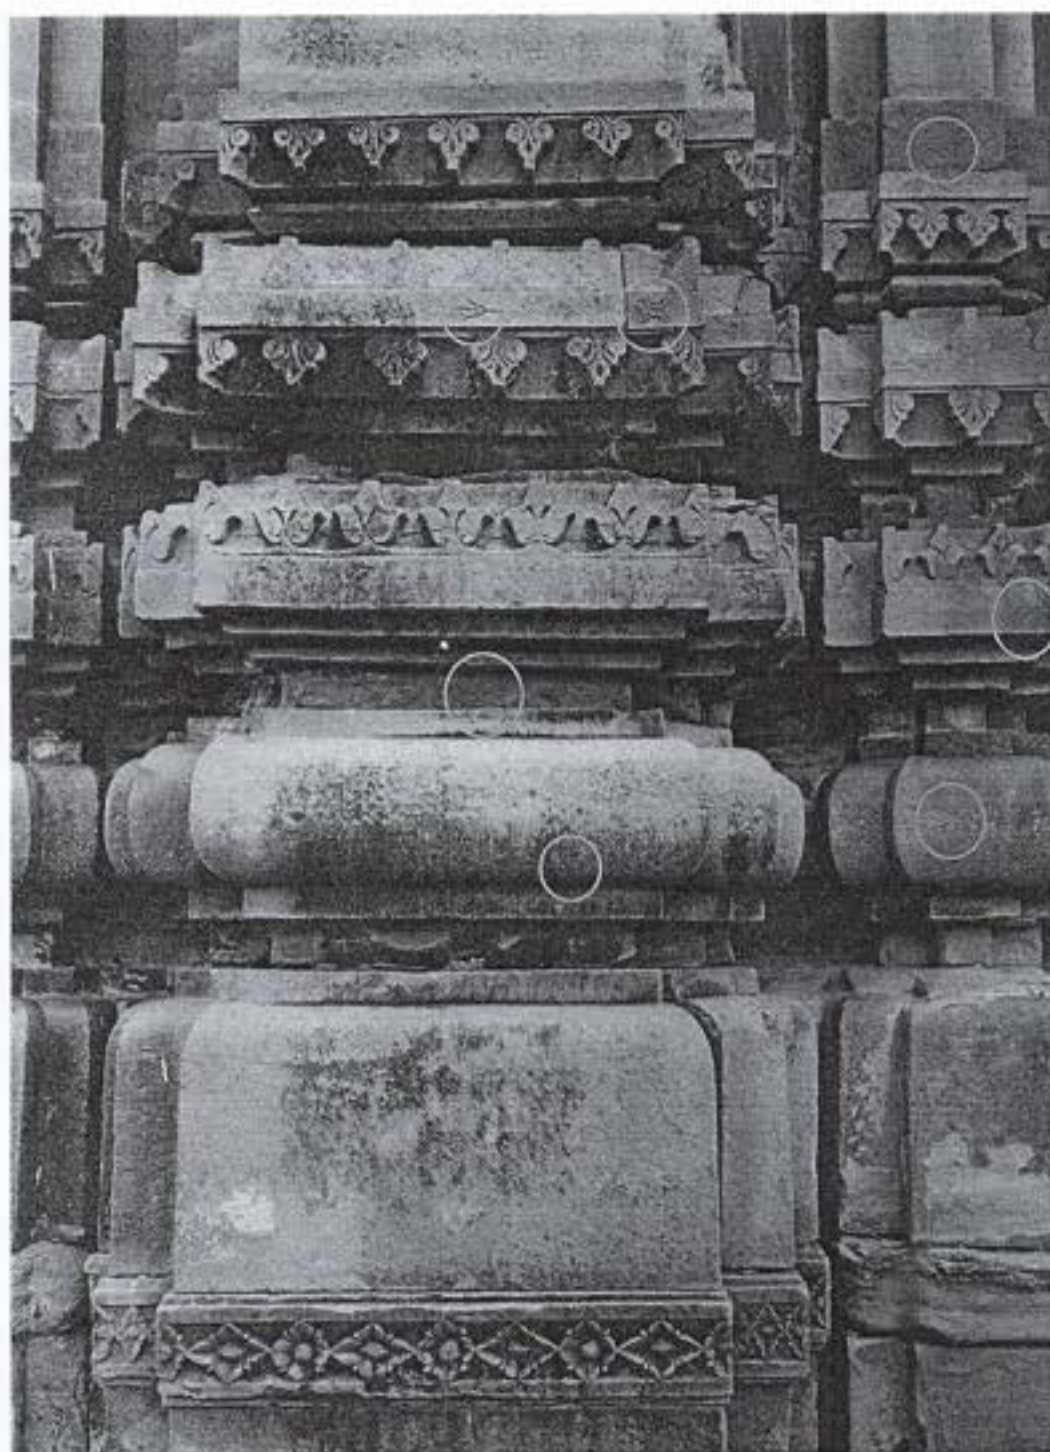
Western Wall: Trident marks

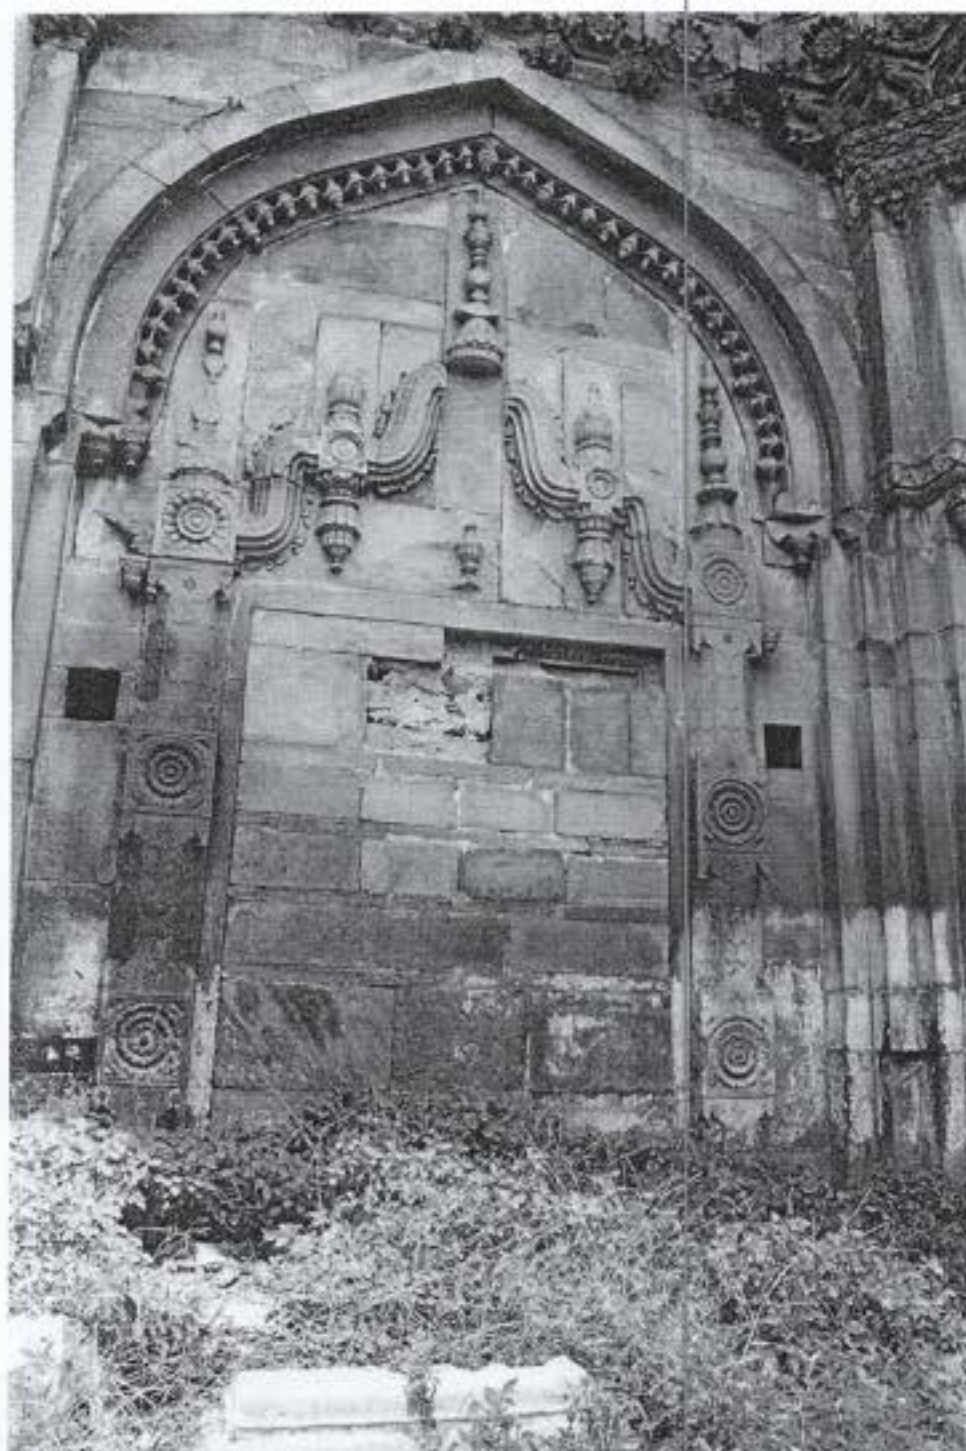
Western Chamber: Entrance in eastern wall, before clearance

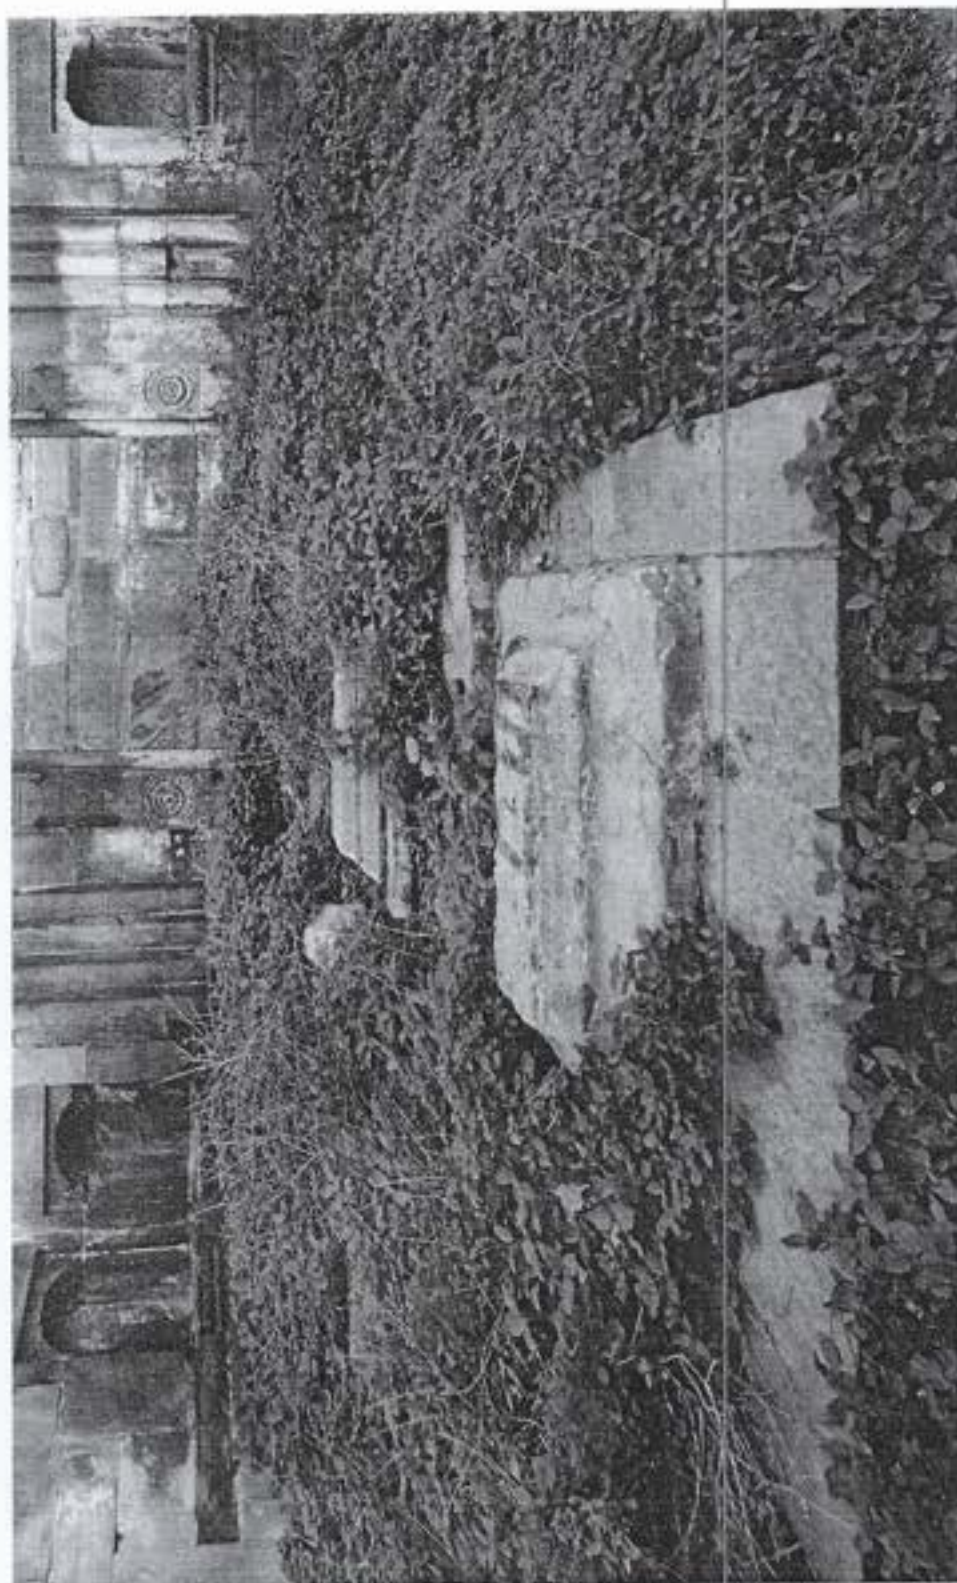
Western Chamber: Graves covered under debris

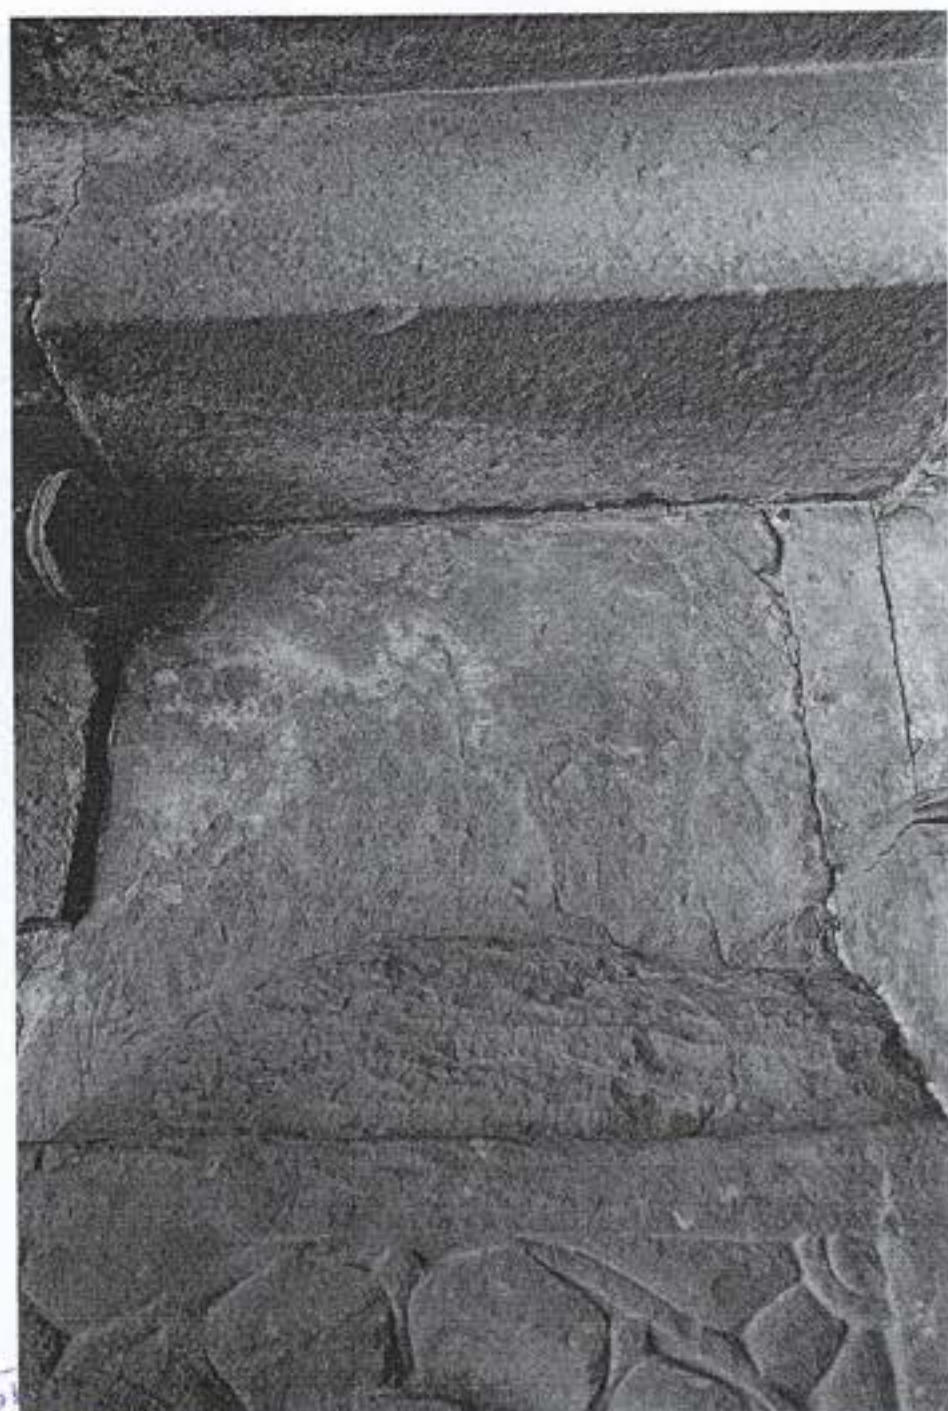
Western Chamber: Chopped off elephant figure on entrance in eastern wall

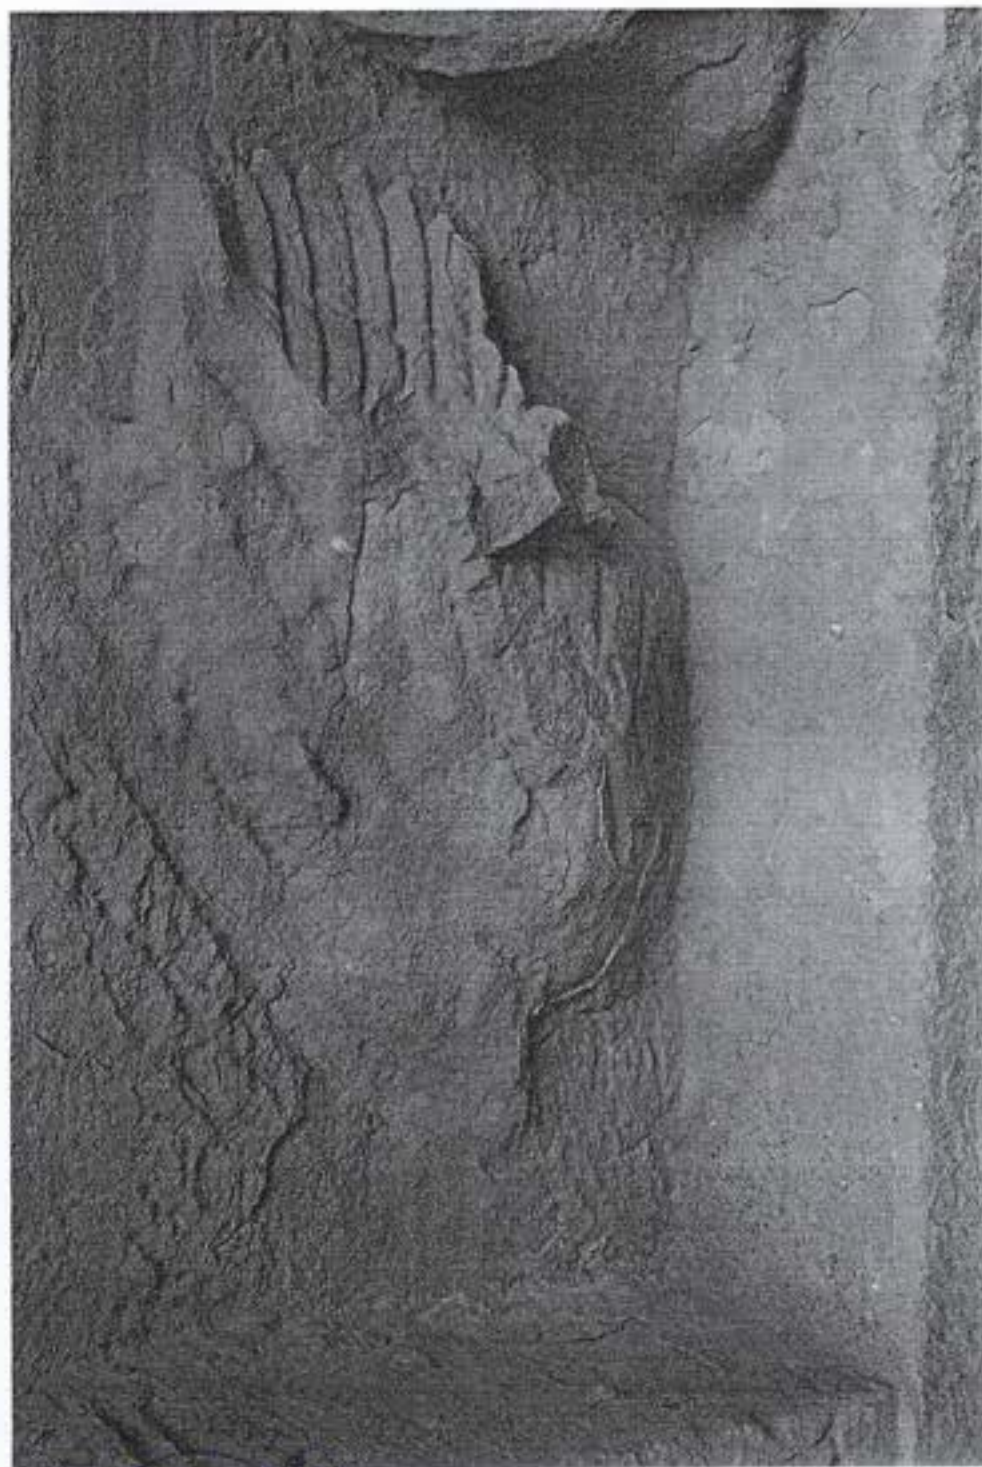
Western Chamber: Damaged bird (kukkut) figure on doorsill
